# **PHASE II DEVELOPMENT OF A BULLNOSE GUARDRAIL SYSTEM FOR MEDIAN APPLICATIONS**

## **MIDWEST ROADSIDE SAFETY FACILITY**

MwRSF Research Report No. TRP-03-78-98

December 18, 1998

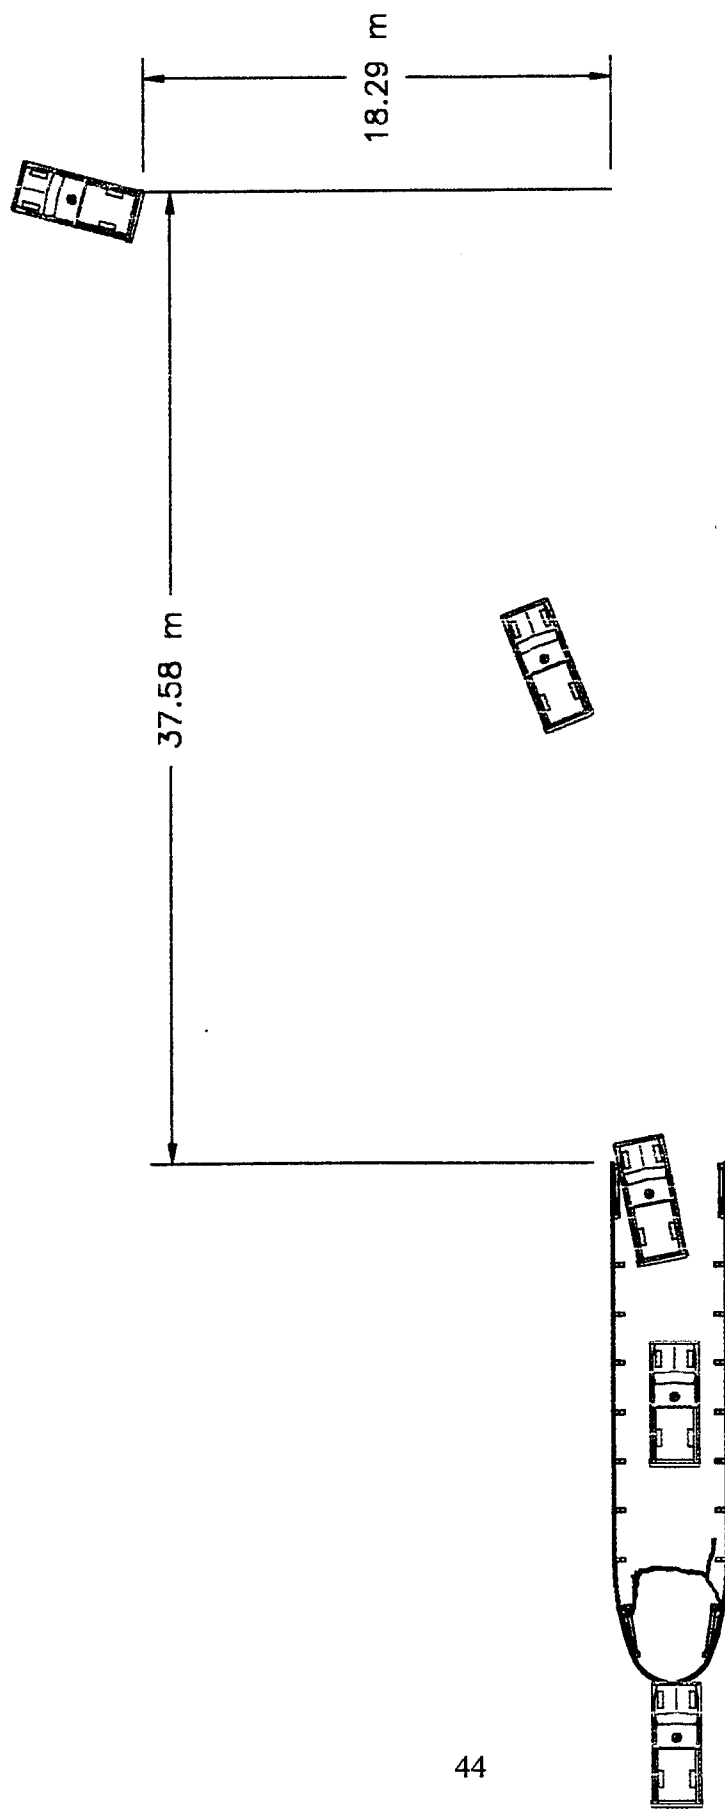
Figure 23. Vehicle Trajectory, MBN-3

Following the initial impact with the pickup truck, the three beam rail immediately began to deform inward. At 0.054 sec after impact, a tear in the three beam rail began to occur in the middle hump just to the right of the centerline of the nose section. The middle hump was aligned directly with the bumper at impact and subsequently fractured. Unlike the middle hump, the upper hump of the rail did not fail immediately after impact. The bottom hump was impacted below the bumper and was pushed underneath the bumper and driven over by the front tires. As the pickup penetrated further into the barrier, post no. 1 on both sides was fractured as the beam wrapped around the posts at 0.076 sec. The first kink in the rail was formed downstream of the first rail splice on the right side of the barrier. At 0.200 sec, this kink impacted and dented the right-side door of the pickup. The pickup truck then continued to penetrate the system, kinking the rail at the cable box on the left side and forming a second kink at post no. 2 on the right side. As the rail wrapped around post no. 2 on both sides, high stresses in the top hump of the three beam, which was now carrying most of the impact load, caused the rail to tear. The tear occurred at 0.208 sec after impact at a location slightly to the left of the centerline of the bullnose. Post no. 2 on the left side of the barrier was also broken due to rail wrapping around the post. Following the rupture of the rail, the pickup truck proceeded

through the middle of the bullnose barrier and fractured post no. 11 at 0.876 sec as it exited the bullnose barrier. Figure 23 shows the trajectory of the pickup truck during the crash test and the final position of the vehicle.

have caused serious injury. The vehicle remained upright during and after collision and the vehicle's trajectory did not intrude into adjacent traffic lanes. Vehicle trajectory behind the test article was unacceptable as the test vehicle penetrated through the barrier and into the median area behind the bullnose. The occupant impact velocities and ridedown accelerations were within the suggested limits imposed by NCHRP Report No. 350.

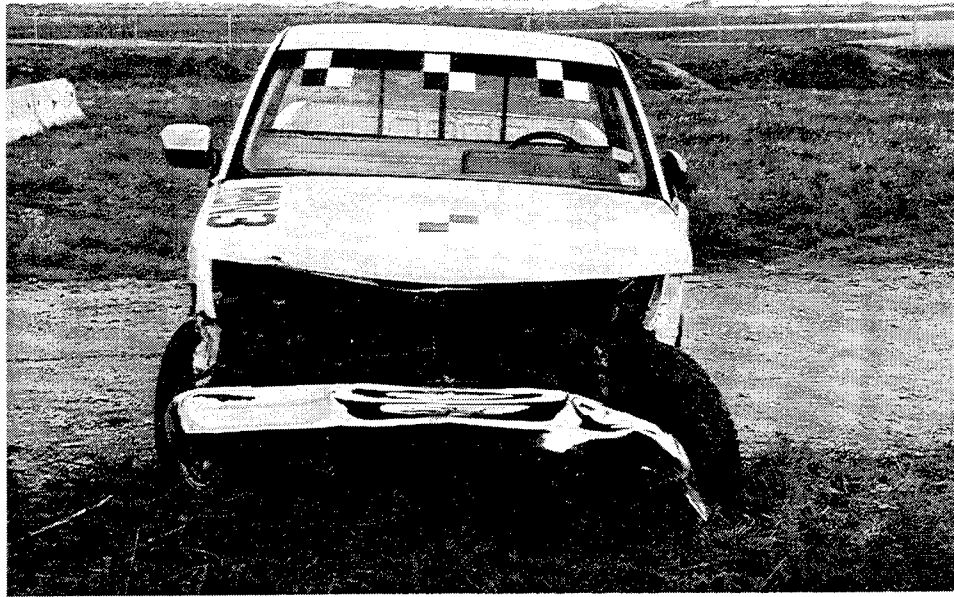
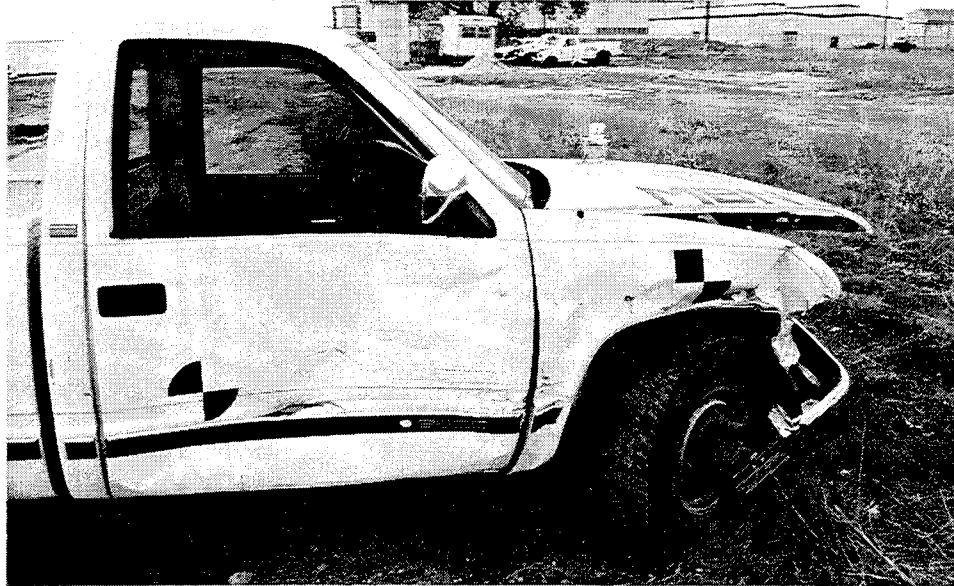
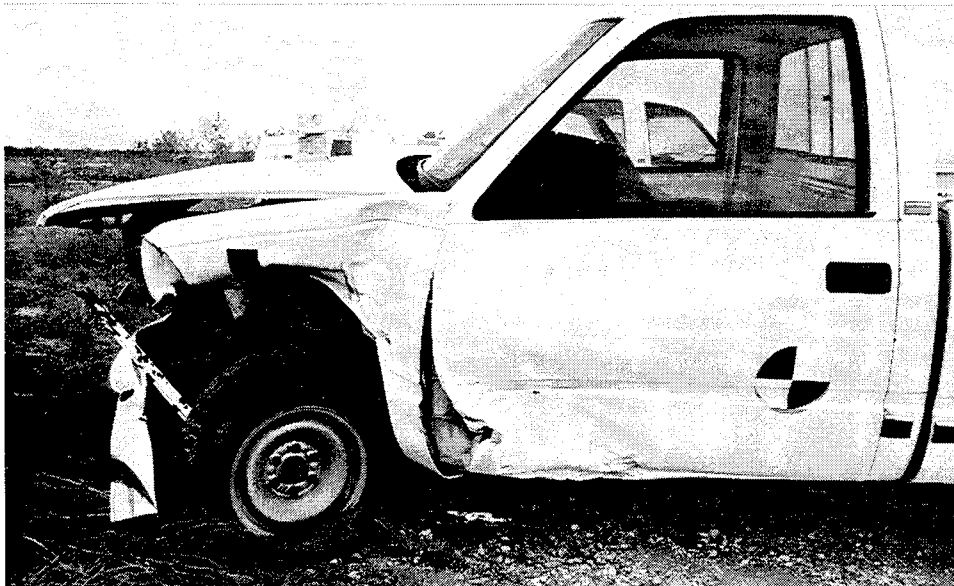
Figure 24. Vehicle Damage, Test MBN-3

Vehicle damage was moderate, as shown in Figure 24. The front bumper and front end of the truck were crushed inward uniformly. The bumper was bent and flattened across the length of the pickup. The left-front fender of the pickup truck was crushed inward due to the barrier impact. The lower-front section of the left door was also crushed inward, and some of the sheet metal on the door was ripped and scratched. The left-front and left-rear tires were cut and deflated. There was no significant rim damage. The tires on the right side were not damaged and remained inflated. The right-front fender was crushed back toward the right door due to the barrier impact. The right door was crushed inward and a 152.8-mm cut was made near the center of the door. The window on the right door was also shattered. There was no crushing of the pickup truck's occupant compartment.

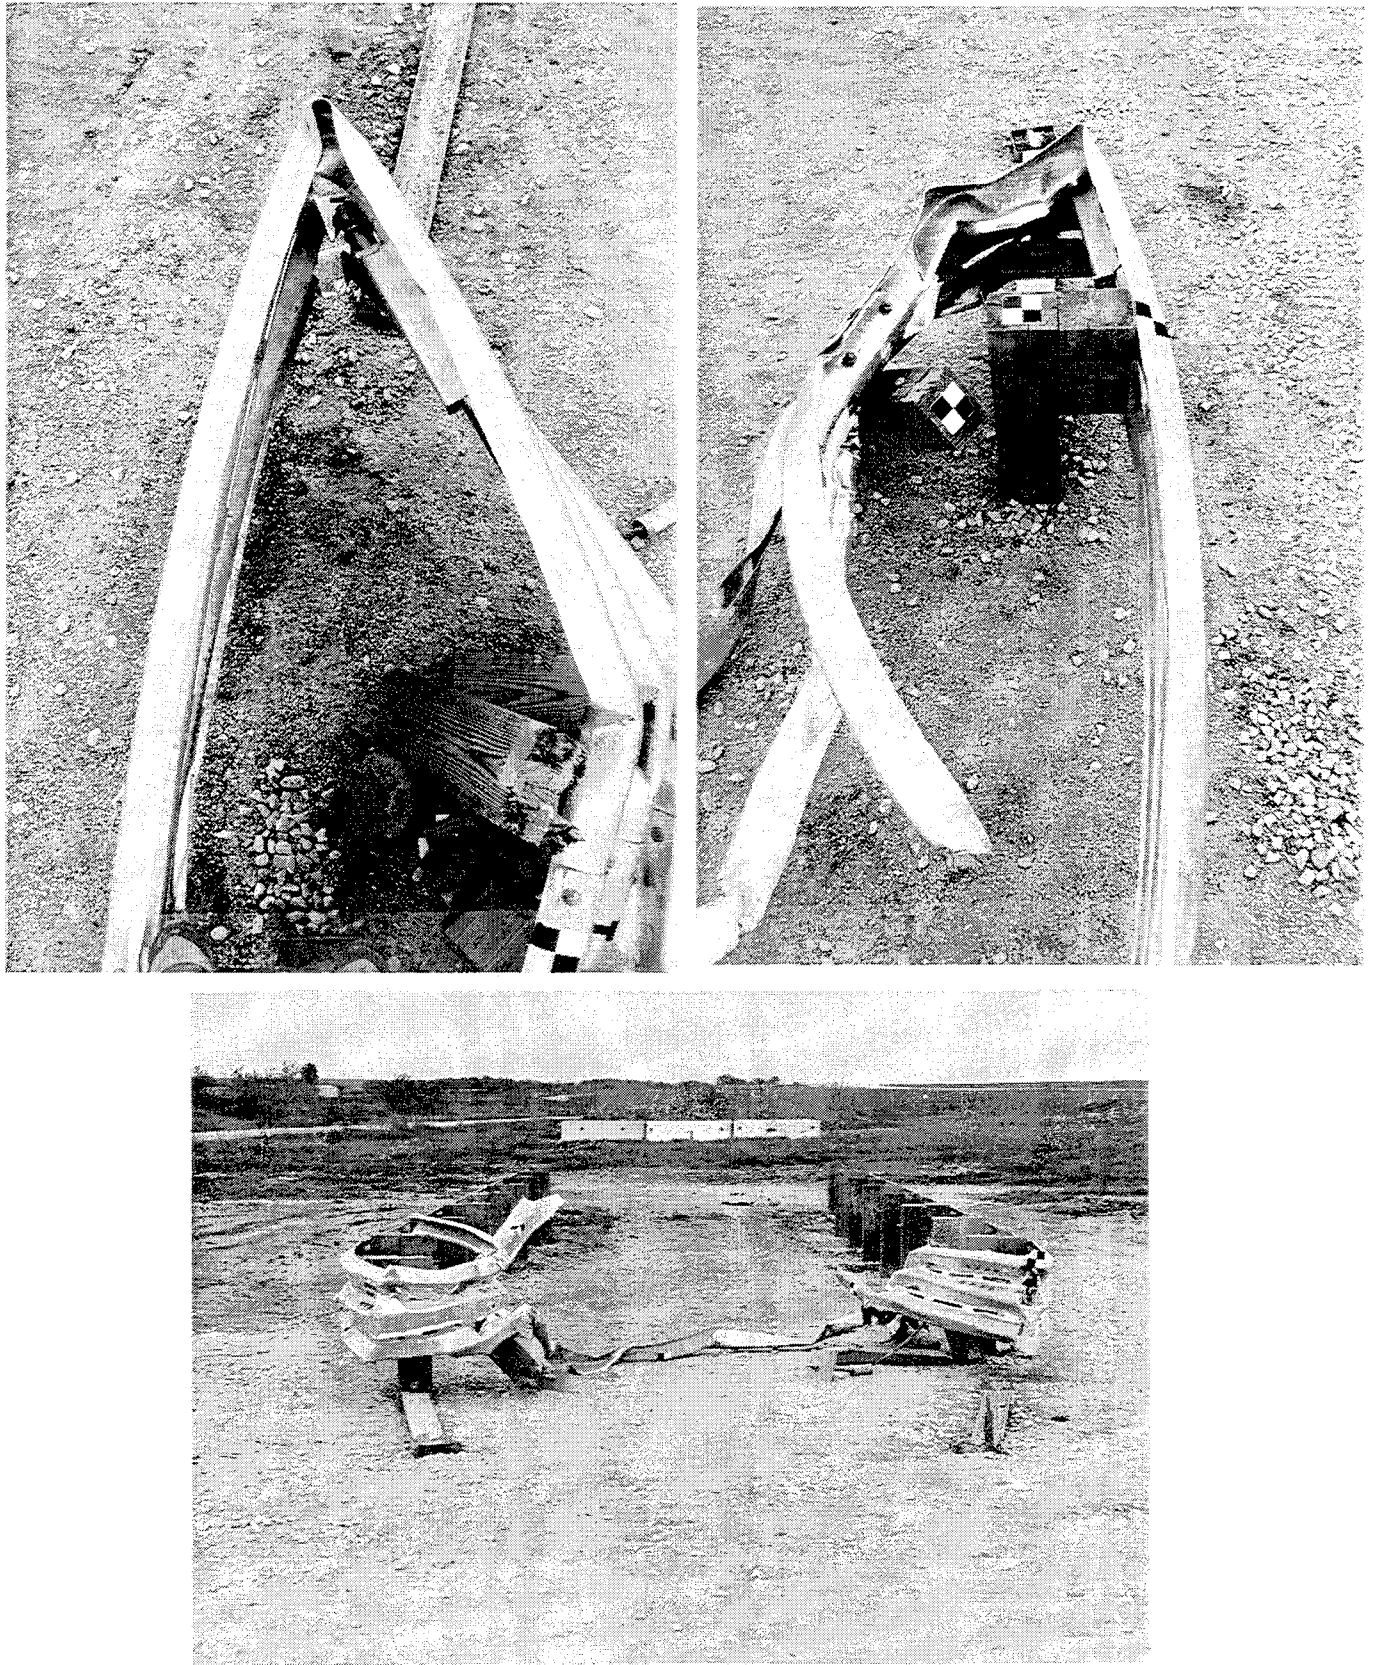
Figure 25. Barrier Damage, Test MBN-3

Barrier damage was extensive, as is shown in Figures 25 through 27. Three of the BCT posts fractured at the hole near the base of the post. Post no. 1 on both sides of the barrier was broken along with post no. 2 on the left side of the barrier. Post no. 11 on the left side of the barrier was contacted and broken as the truck exited through the middle of the barrier. The thrie beam buckled and bent around the cable box 813-mm upstream of post no. 2 on the left side of the barrier. The thrie beam also buckled at two locations on the right side of the barrier. The first buckle occurred at the start of the first set of slots downstream of the first rail splice, while the second buckle occurred around post no. 2.

The thrie beam tore in two places during the pickup truck impact. The first tear occurred 381-mm downstream and to the right of the nose of the barrier in the middle hump of the thrie beam. The second tear occurred 343-mm downstream and to the left of the nose of the barrier in the top hump of the beam. The lowest hump in the rail did not tear completely but did have partial rupture 381-mm downstream and to the right of the nose of the barrier. There were also some cuts in the rail on the right side of the barrier during impact. Major rips in the rail were found at 279-mm and at 178-mm upstream of post no. 1.

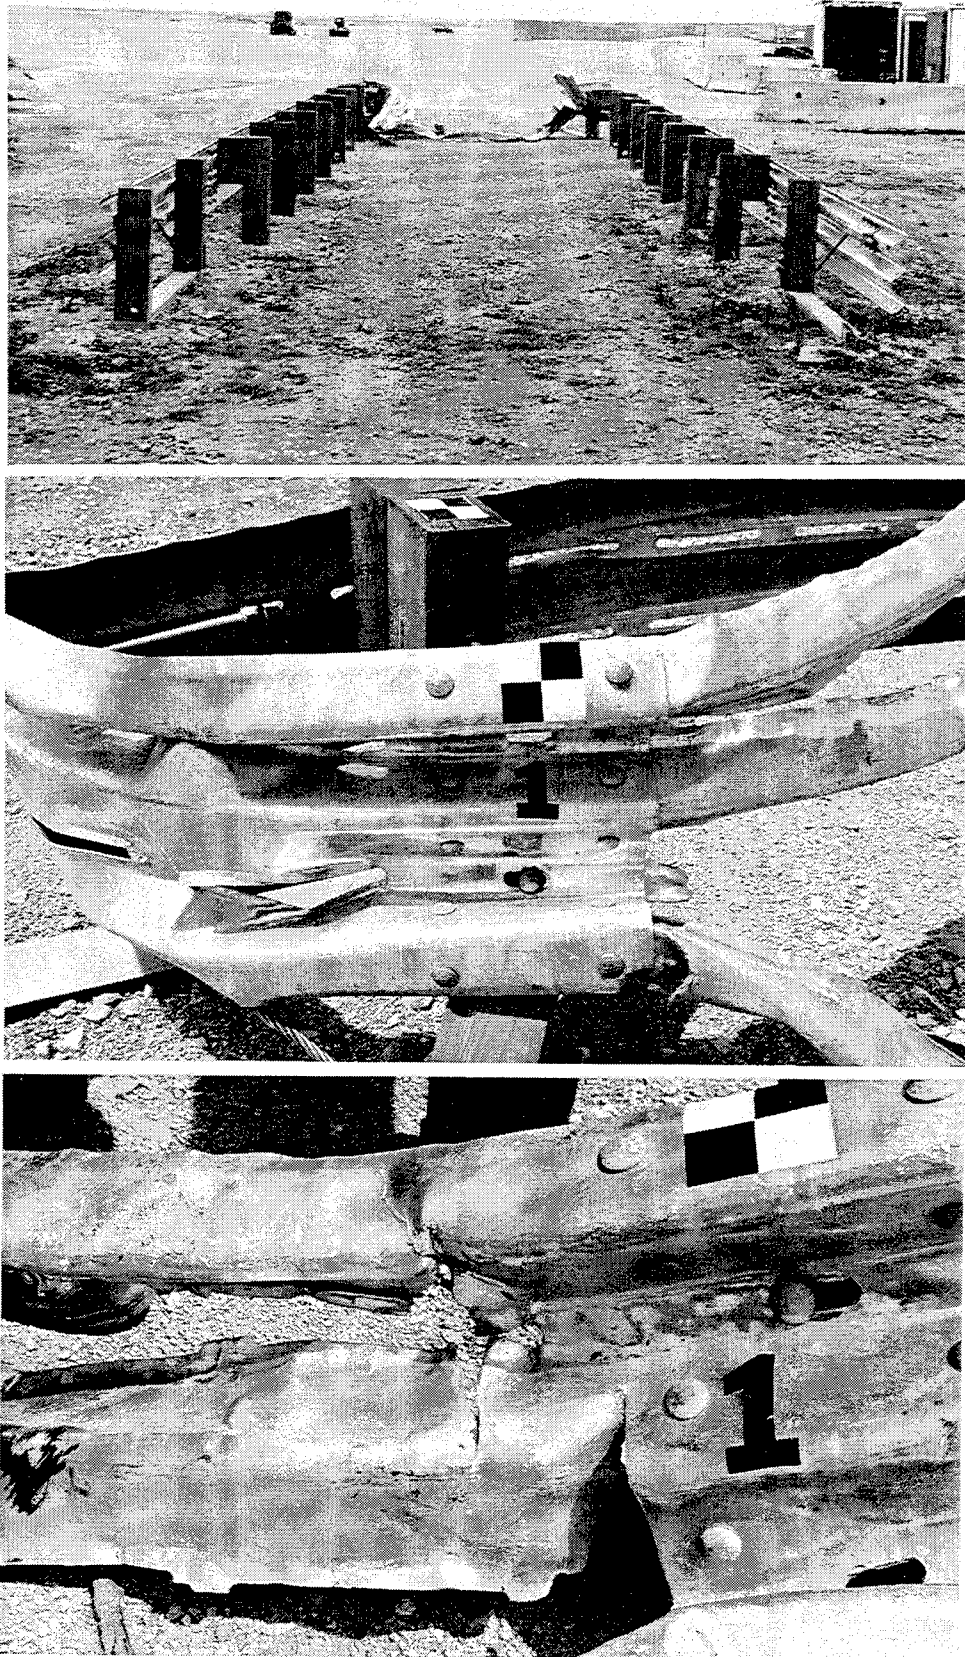
Figure 27. Barrier Damage, Test MBN-3

The failure of the system to meet all of the safety performance criteria was directly attributed to the fracture of the thrie beam. The fracture of the thrie beam in test MBN-3 occurred more rapidly than during test MBN-1. This behavior was believed to be attributed to the direct alignment of the Chevrolet pickup truck's front bumper with the middle hump of the thrie beam in test MBN-3. It is believed that this impact condition caused high stresses and strains to be generated immediately in the middle hump of the thrie beam nose section, thus leading to rapid rupture of the middle hump. For test MBN-1, the Ford's front bumper was aligned to contact both the top and middle humps of the thrie beam. This impact condition resulted in a more gradual increase and distribution of stresses and strains in the middle and top humps. However, it was noted that rail rupture still occurred. It became obvious to the researchers that the middle and top thrie corrugations were inadequate to contain the impacting head-on pickup truck in the present configuration. The top mounting heights for the Ford and Chevrolet bumpers were 737-mm (test MBN-1) and 622-mm (test MBN-3), respectively. A comparison of the bumper heights is shown in Figure 28.

Design changes were therefore necessary to contain the pickup truck by preventing rail fracture or contain the pickup even if rail fracture occurred. However, these design modifications, intended to adequately contain the pickup truck impact, were to be incorporated without adversely affecting the small car's impact performance.

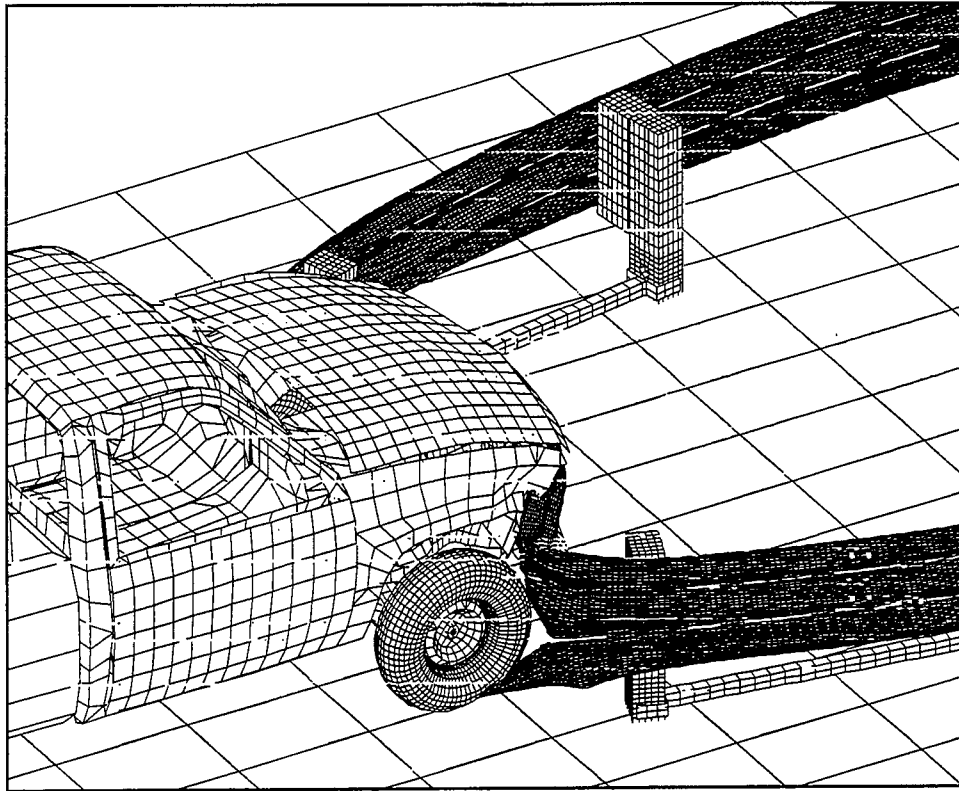
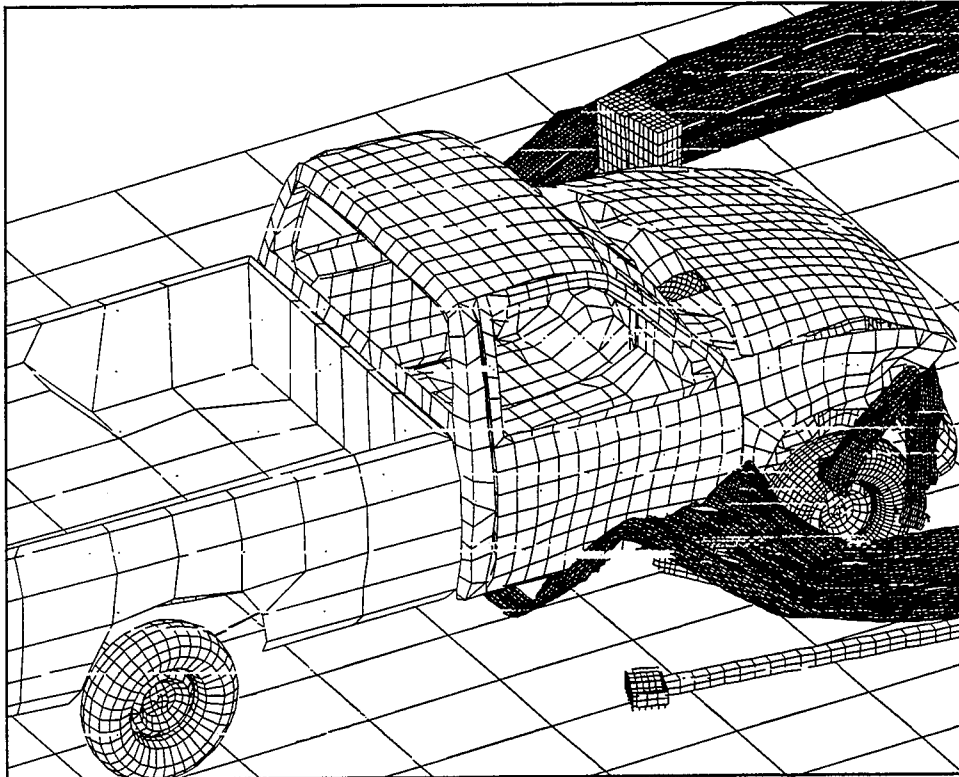
Figure 32. MBN-3 Simulation - Truck Tears Through Guardrail

With material failure and rotating tires defined, simulation of test MBN3 was repeated. This time the results were very encouraging, as shown in Figures 32 and 33. As the truck impacted the rail, the three peaks separated, wrapping themselves around the front of the truck. The lower peak contacted the tires and was pushed down and driven over by the front tires. As the rail wrapped around post no. 1, the upper two peaks of the rail tore just before the first splice in the rail. The vehicle then proceeded to penetrate behind the bullnose system. The velocity comparison between test and simulation is shown in Figure 33. After 200 ms, the vehicle was essentially rolling unconstrained and thus, not of concern.

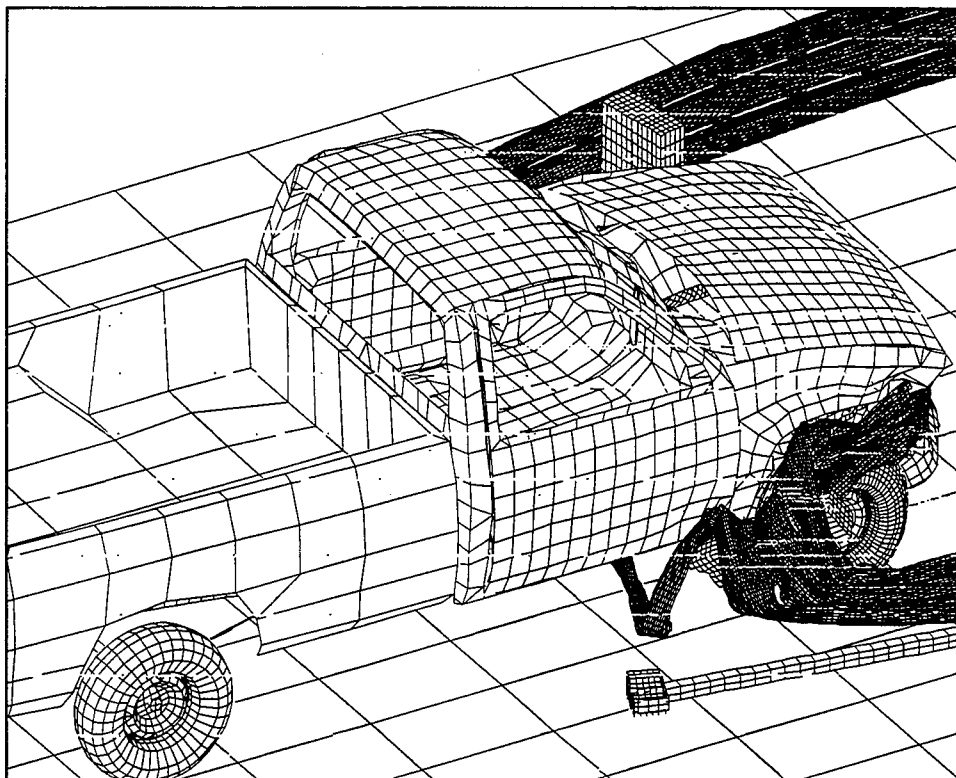
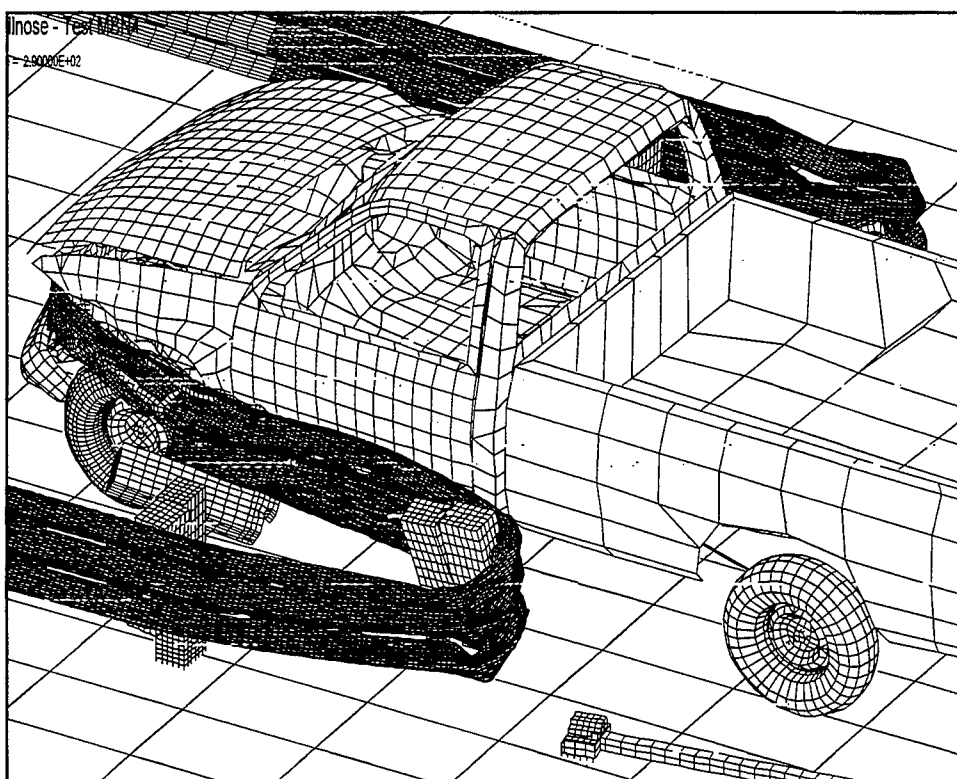
Figure 38. Simulation Results, Test MBN-4

Results of the simulation indicated that the cable design would adequately contain the truck during the frontal impact test, as shown in Figure 38. The bullnose simulation took 220 hours for 367 ms of simulation on an SGI Octane. It is noted that the simulation was stopped at 367 ms due to a power outage. The model contained approximately 60,000 deformable elements. Because of the long simulation times, the permission for construction to proceed was given with only partial simulation results available. The permission for testing given after it was clear no further useful information could be gathered from simulation in regards to the proposed design.

added behind the top and middle humps of the nose section of thrie beam rail. A 7 x 19 cable was chosen such that one of the two cables was capable of containing the impacting vehicle. Cables were only placed behind the first rail section because it was the only section that had failed in previous testing. It was believed that the rail sections after the nose section would be active in containing the vehicle, and therefore, the use of longer cable lengths was not deemed necessary. The cables were attached to the guardrail using three U-bolts per cable to fix the cables behind the top and middle humps of the thrie beam. The ends of each cable were fitted with “Cold Tuff” buttons and clamped between formed steel plates located at the guardrail splice at post no. 1 on each side. The cable plate and the cable detail are shown in Figure 37.
